## **Corrosion Mechanism of L316 Stainless Steel in Methanol Recovery Towers of Gas Fields**

### **Abstract**

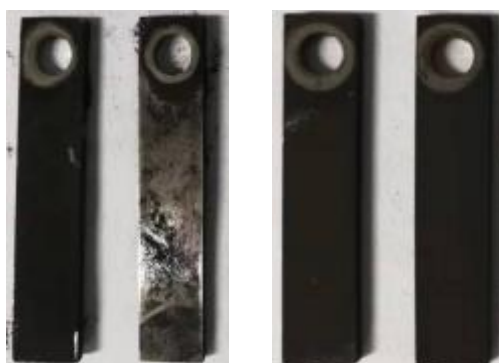
Fig. 3 Corrosion Coupons Located in the Fractionating Column

(a) The 10th Tray (b) The 38th Tray

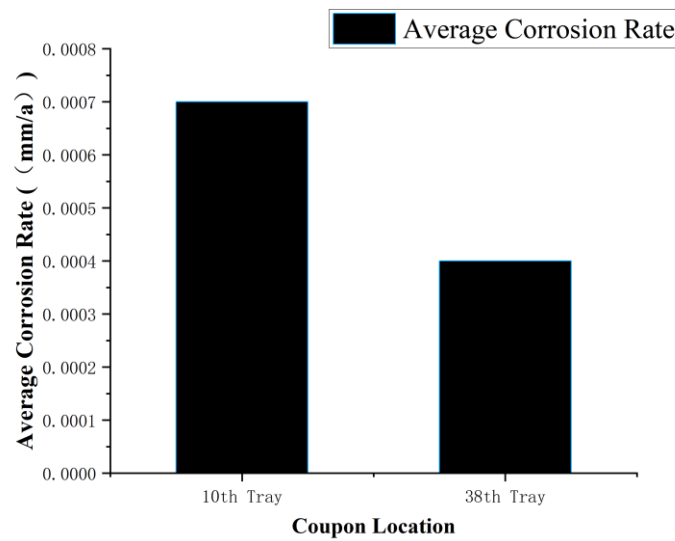
Fig. 4 Corrosion Rate Results of L316 Coupons

As can be seen from Figure 4, the corrosion at the bottom of the column is more severe than that at the top. However, the uniform corrosion rates at both locations are below 0.025 mm/a, which is classified as mild corrosion.

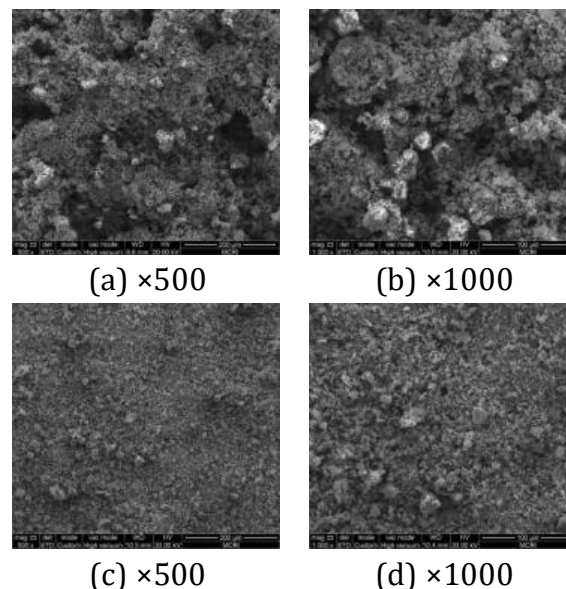
Fig. 5 SEM images of corrosion coupons: (a)(b) the 10th tray; (c)(d) the 38th tray

SEM and EDS analyses were conducted on the surface of the coupon, with the results presented in Figure 5 and Figure 6, respectively. The surface of the coupon was observed to be rough and irregular, characterized by significant corrosion features, granular structures, as well as micro-cracks and pores.

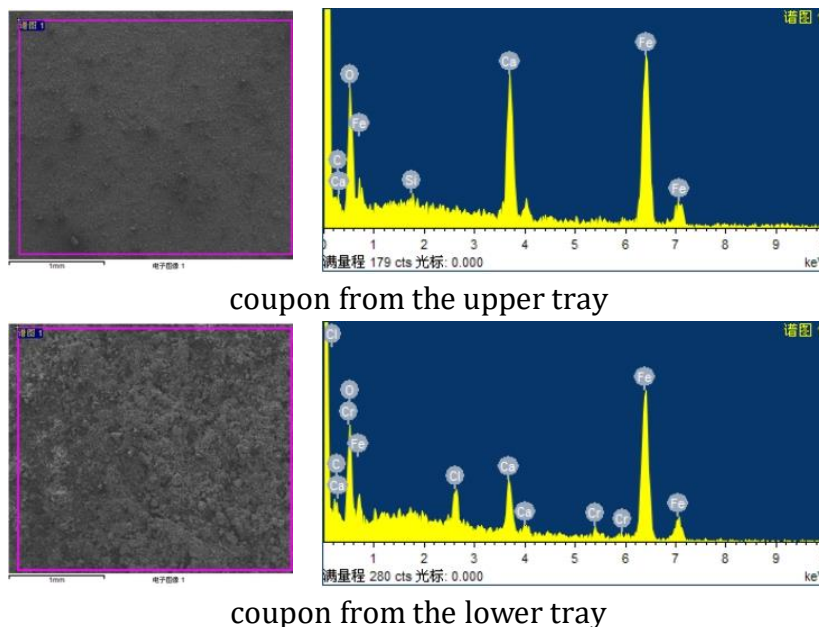
Fig. 6 EDS analysis of corrosion coupons from the upper and lower trays

The results of EDS elemental analysis are presented in Table 2. The surface composition of the coupons was similar, primarily consisting of C, O, Ca and Fe. This is mainly attributed to the fact that the coupon surfaces were covered with scale.

The produced water contains a high concentration of  $\text{Cl}^-$ , exceeding 15,000 mg/L. EDS analysis results indicate the presence of  $\text{Cl}^-$  on the coupon from the lower tray, while it was not detected on the upper tray coupon. Consequently, pitting corrosion occurs on the lower tray and is more severe than uniform corrosion.  $\text{Cl}^-$  is a highly aggressive ion that adsorbs onto the stainless steel surface, dissolves the passive film by forming  $\text{CrCl}_3$ , and thereby destroys it, initiating pitting corrosion. When the mass concentration of  $\text{Cl}^-$  exceeds 0.5 g/L, stainless steel becomes susceptible to pitting and crevice corrosion [7-8]. Furthermore, higher  $\text{Cl}^-$  content in the corrosive medium lowers the critical pitting temperature (CPT) of L316 stainless steel, increasing the risk of pitting corrosion [9].

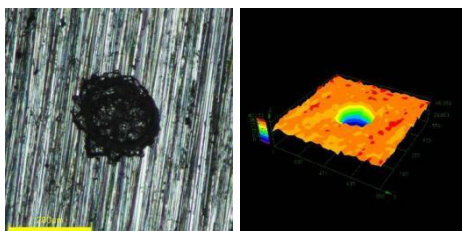
Fig. 7 Pitting morphology on the corrosion coupon from the lower tray

Pitting corrosion was observed on the L316 stainless steel coupon from the lower section of the fractionating column. The morphology of the pits was analyzed using a 3D profiling system, and the results are shown in Figure 7. The maximum pit depth on the L316 coupon was 70  $\mu\text{m}$ , with a pitting rate of 0.544 mm/a.

The high chloride ion content and elevated temperature are identified as the primary causes of corrosion in L316 stainless steel. Moreover, these two factors exhibit a synergistic effect that accelerates the corrosion rate. Therefore, corresponding mitigation strategies targeting these factors should be implemented in the future to reduce corrosion.
