## Failure Analysis of the Drilling Pump Valve Surface

### Abstract

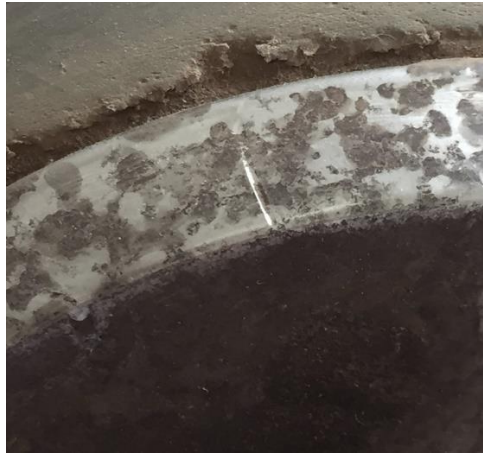
From on macroscopic observation of the pump valve failure, in terms of the body sealing ring, the body sealing ring on the bottom edge and the cohesion of the body prone to fall off chunks of material or hard to fall off, sealing ring and seat contact cone parts due to the effect of erosion corrosion of the mud which is easy to produce linen small pits, see Fig 1 and Fig 2. The damage of the valve sealing ring is material loss mainly, the loss caused by pump valve sealing. Drilling pump valve body and seat at work can generate the wear and deformations after a period of time, the valve body and valve seat reinforced contact site can see obvious deformation, the body parts contact with subsidence characters. Between the valve and valve seat frequently on the both cone has obvious block off. Seat cone comes into being two cone obviously, seat conical surface contacts with the body of the rubber sealing ring, cone under direct contacts with body rigidity, so cone socket appears the characteristics of sinking under the seat. The valve body and seat directly affects the work of the drilling pump valve sealing and the fast of the opening and closing valve after wear and deformation, eventually leads to the leakage of drilling fluid and the unpunctual circulation of the drilling fluid.

Fig. 1 The drilling pump valve body sealing block off

Work through the pump valve failure analysis, in view of its bad working environment, according to the main failure forms, suggest to strengthen which becomes particularly important. It is recommended that where the valve face weak laser cladding cemented carbide powder, improve its strength, hardness and prolong its service life.

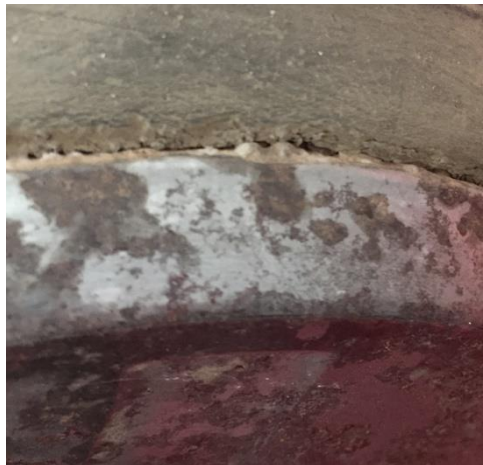
Fig. 2 The drilling pump valve body sealing hole fall off

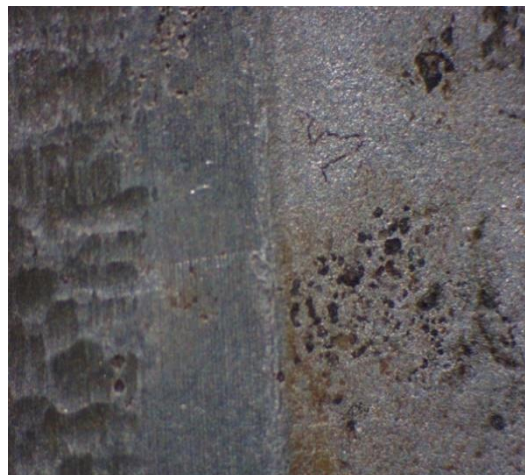
From low power microscope (models for EZ460D, choose eyepiece 10x, objective 3.5x) under observation, see Fig 3 and Fig 4, finding on the surface of the valve has obvious erosion pit with the characteristics of water ripple erosion and erosion groove. The material of the valve surface produces plastic deformation and sharply develops a chisel pit, plastic extrusion or bump material accumulation and erosion wear morphology. There are abrasive wear properties of the plough cut type groove and a lot of minor scratches. And it can be clearly observed the typical fatigue wear properties of hemp dot and honeycomb flake peeling pit. Fatigue damage is local with deep a round hole. Because the force of solid particles in the drilling fluid shocking the surface of valve is not the same, the working face of the pump valve is formed all kinds of pit shades. Especially it found that the drilling pump

valve seat's cone and the vertical plane intersection damage very serious. Vertical plane appears many grooves where has some peeling pits on a cone. Therefore, in the low power microscope we obtain the most serious destruction place of the drilling pump valve.

Fig. 3 The seat cone and the shape of vertical plane junction ( $\times 35$ )

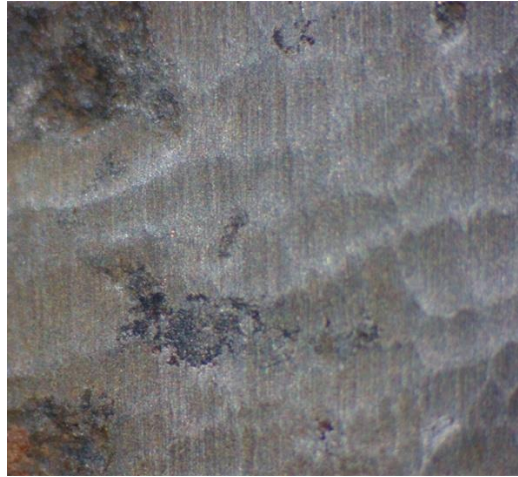
Fig. 4 Water wave shape topography ( $\times 35$ )
