## Analysis and study on typical diseases of hydraulic concrete buildings

Jianbo Zheng

Binzhou University, Binzhou, 256600, China

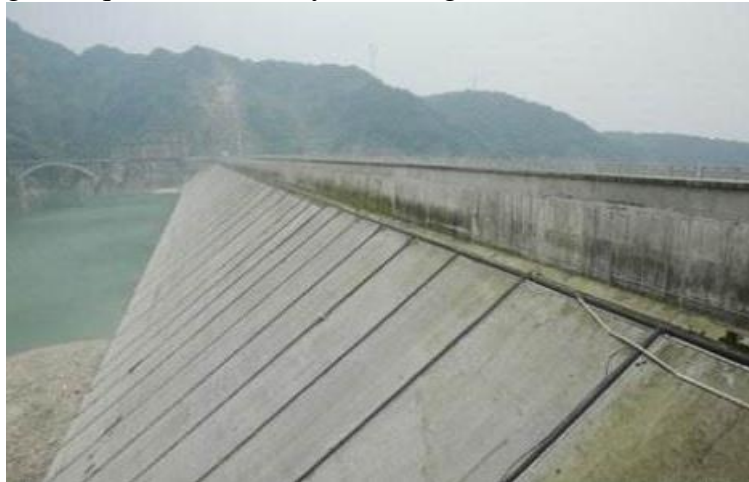
Figure 1 Danjiangkou hydropower station

During the construction of the dam of Danjiangkou hydropower station, 3332 cracks were found. After two tests, 1152 cracks were found and more than 90% of the cracks appeared after the operation of the dam. There are 171 cracks in seepage leakage and through the cracks in the dam, accounting for 14.8% of the total [2]. In the cracks in the Danjiangkou dam, the areas that are more serious in nature and may affect the safety of the dam are:

Due to the reasons of design and construction, the quality of the dam itself is relatively poor, and there are many cracks, and the leakage of seepage is widespread in addition to the drainage pipe in the dam body. Seepage leakage is the 42.1% of the total cracks in the dam. There are penetrating cracks in the basic corridor, water leakage at the bottom of the dam body, and horizontal seams at the height of 143 to 145m, and the problem is more serious.

The elevation 123m of No. 2 dam section and the elevation of No. 3 dam section are below 110m, and the top of the upstream seepage prevention board has been disconnected from the dam body. There are cracks in all the corridors in each layer, especially the elevation 131m corridor dripping throughout the year, and water seeping in the downstream of the corridor.

During construction, there are penetrating cracks in the area. During operation, cracks on the piers developed due to frequent opening and closing of gates. For example, under the condition of high water level and strong earthquakes, there may be damage.

In addition to the cracks in the dam body of the Danjiangkou hydropower station, the cracks in the reinforced concrete structures such as the power plant are also noticeable. As the main building at the top of the asphalt aging sealing cracks and concrete cracks off, there are also many irregular: main building internal ceiling concrete cross exists in many of the crack width of 0.3 ~ 0.6mm; existence of circumferential and radial cracks within the main building around the concrete generator ground; generator bracket concrete layer all produce shear crack; reinforced concrete the highway bridge also appears vertical cracks [3].

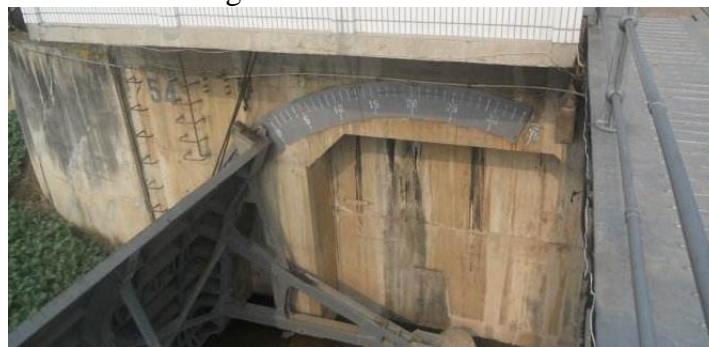
Figure 2 Flood diversion sluice

The 54 - hole skid plate in front of the sluice is completely cracked, and the steel corrosion is serious in the crack, which has lost the anti - seepage and drag - resistance effect. The size of the hindrance plate is 15m×19.5m×0.5m. Concrete strength R28=140kg/cm<sup>2</sup>. After the dam was built, cracks appeared, and the cracks continued to develop in the future. Generally, there is a penetrative crack in the middle of the long and wide direction of the slide plate. The plate is divided into 4 parts, some of them appear two cracks in the middle side of the larger size, and the board is divided into 6 parts. The sampling inspection shows that the cracks have cracked the floor. The corrosion length of the main rib of 12mm in the crack is 1/3, and the 6mm steel has been rusted and broken [4]. The concrete quality surface is still available, but the bottom honeycomb is many and the quality is poor. It was found that the total length of the crack in the skateboard was 4350.4m, and the penetration was 2042m.

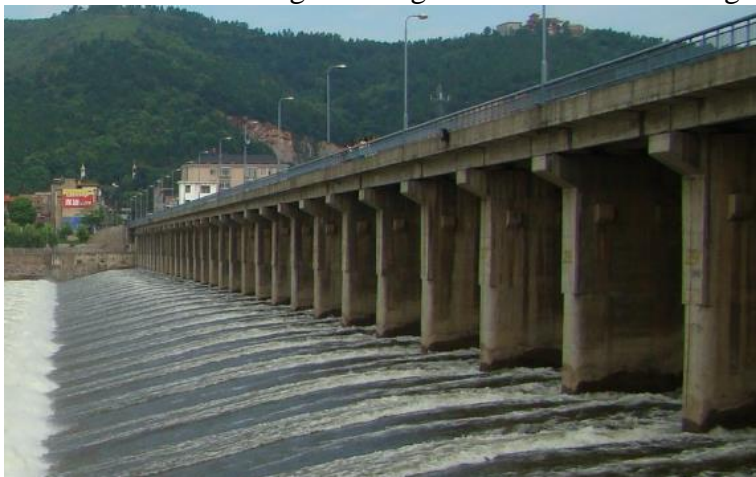
Figure 3 North Gate of the 54 hole of apron

North Gate of the 54 hole of apron, stilling slope bottom and the gate body on both sides of the downstream wall there are cracks, crack depth is 3 ~ 40cm. There are many cracks in the South sluice, only the bridge of highway bridge has 7213 cracks, the general width is about 0.2mm. The crack distribution has certain regularity, the eastern half of the west gate half crack 723, which may be related to the settlement of sluice in two things about the uneven [5]. At the same time, non-reinforcing holes and cracks and cracks fixing hole 495, mainly because the reinforcing hole span is small, and the structural stiffness and strength are higher than non-reinforcing hole.

Causes of Jingjiang Flood Diversion Project of North Gate floor serious crack is complicated. According to a preliminary analysis of brake pipe, mainly in the following aspects: structure design defects, such as the bottom plate of large size, large amplitude natural temperature; the construction quality is not uniform, the surface quality of concrete is good, but the quality of concrete surface below 10cm; the change of operating conditions, poor management, such as anti-slider exposure not timely maintenance, in large temperature differences amplitude common cracks [6].

In view of the cracks above the north gate, especially the 54 holes before the sluice, all of them are broken through, which has lost the original anti-seepage and drag function, and may pose a great threat to the stability of the sluice during operation. At the same time, the sluice floor is also generally cracked, and nearly half of the crack depth is more than 40cm.

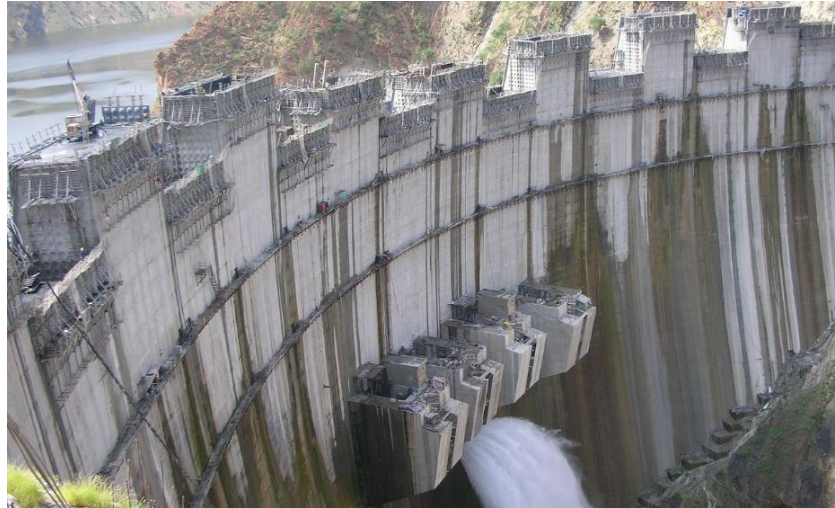
Figure 4 Corrosion detection of steel bar

There are two main reasons for the corrosion of the steel bar in the reinforced concrete structure of hydraulic engineering. One is the concrete erosion of carbon dioxide in the air, the alkalinity decreased and the formation of carbide, when the concrete carbonation depth to thickness of reinforced protective layer, the passivation film on steel surface will make damage to the original, then reinforced in water and oxygen is produced under the action of electric chemical corrosion, resulting in corrosion of steel. On the other hand, the hydraulic reinforced concrete buildings in the coastal area are invaded by Cl<sup>-</sup> in seawater, sea breeze and salt fog, or in the reinforced concrete structure construction, some admixtures, such as calcium chloride, are mixed with Cl<sup>-</sup> in the construction.

Cl<sup>-</sup> is a strong activator for corrosion of steel bars. Some foreign data show that when the content of Cl<sup>-</sup> in concrete reaches 0.4% of the weight of cement, the steel begins to rust. Once the steel reinforced concrete structure in the occurrence of corrosion, will appear volume expansion, expansion in 2~4 times, this time in the concrete will produce great expansion stress, which will be reinforced outside the protective layer of concrete cracking, the formation of cracks along the reinforcement, called "longitudinal crack". While the cracks, and the carbon dioxide, oxygen and water in the air more easily into the concrete, which accelerated the development of carbonization and corrosion, bonding force between steel and concrete is greatly weakened, the external protective layer of concrete was caving, exposed steel bars, the effective cross section due to corrosion and weakened, the bearing capacity decreases rapidly, collapse finally, even may cause the entire building or structure.
