# Fatigue fracture failure analysis of wind turbine blade root bolt

Wind turbine blade; High strength bolt; Fatigue crack; Failure analysis.

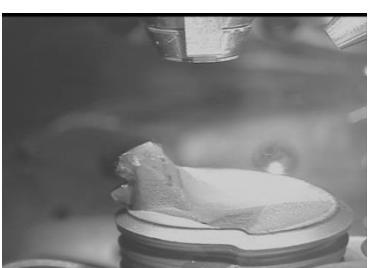
Fig. 1 Bolt cutting exterior appearance

Figure 1 reveals that the cross-sections of the first two sets of bolts are generally smooth with slight undulations, while the third set exhibits noticeable fracture protrusions. The fracture surface of the third set indicates three distinct regions: the crack initiation zone, propagation zone, and instantaneous fracture zone, discernible by directional patterns along the fracture. As depicted in Figure 2, the surface of the crack initiation zone displays a relatively smooth and stable concavity. It can be inferred that the original defect at the thread is the primary cause of stress concentration, acting as an external factor inducing crack initiation in the bolts.

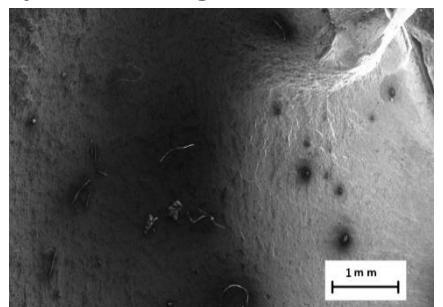
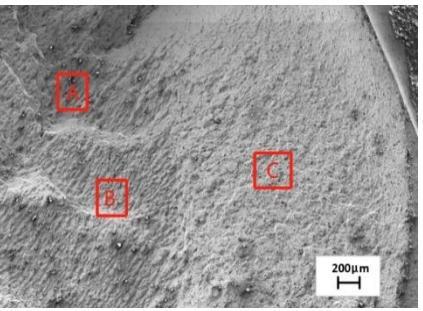
Fig. 3 Scanning electron microscope microscopic fracture morphology

Figure 3 provided image illustrates the scanning electron microscope's microscopic view of the bolt fracture surface. Clearly, the fracture aligns with high-cycle, multi-source fatigue failure, with the crack initiation point situated at the stress concentration zone near the bolt threads, highlighting the multifaceted nature of crack initiation.

A, B, and C denote the fatigue fracture surface, fatigue initiation zone, and crack propagation zone, respectively. Notably, the crack originates from the edge region. Upon closer inspection in the magnified view, this region appears relatively smooth, displaying a deeper coloration. Under repetitive cycles of opening and closing, it experiences wear, progressively radiating radial streaks from the surface towards the interior.

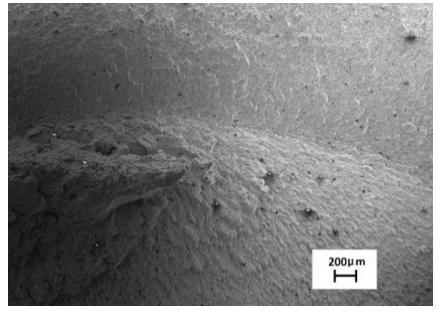
Fig. 4 Sectional extrusion ridges Following the emergence of slip bands on the specimen's surface due to irreversible cyclic deformation, the fracture surface displays Figure 4 "extrusion ridges" and Figure 5 "intrusion grooves." These characteristics arise from uneven surface slipping of metal under the influence of alternating loads. The crack nucleation sites gradually expand and interconnect under the action of alternating stress, ultimately evolving into macroscopic fatigue cracks[7].

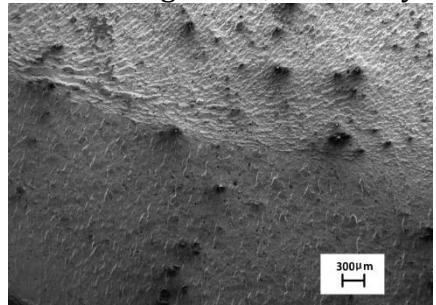
Fig. 6 Boundary between initiation zone and expansion zone

Upon observing the region depicted in Figure 6, numerous fatigue arc lines are discernible, with cracks generally parallel and perpendicular to the direction of crack propagation, extending in the same direction as the secondary cracks. As cracks propagate and the material gradually undergoes deterioration, the remaining cross-section proves insufficient to withstand external loads, leading to rapid instability and the abrupt fracture of the specimen in the instantaneous failure zone. Bolt fractures result from the convergence of cracks expanding from different regions, forming a peak line upon intersection, thereby inducing fatigue fracture steps akin to those depicted in Figure 7.

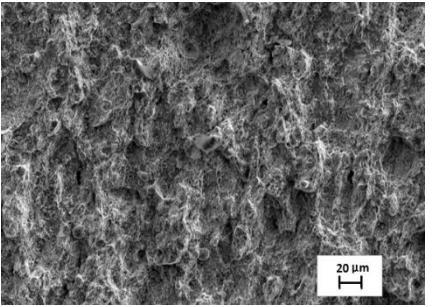
Fig. 8 Fracture impurity and dimple morphology

The crack originates at the thread root, as evident in Figure 8, progressing towards the thread core in a fatigued manner. The crack propagation zone exhibits fatigue striations, while the morphology in the instantaneous failure zone manifests as ductile dimples. The mechanism

behind bolt fracture is fatigue failure, and on the fracture surface, there are discernible metallike precipitates. Even after cleaning with an ultrasonic cleaning device before inspecting the fracture surface, these residues persist, indicating that impurities did not adhere to the bolt surface after the fracture occurred. This metallic impurity could also be one of the contributing factors to the initiation of the crack.

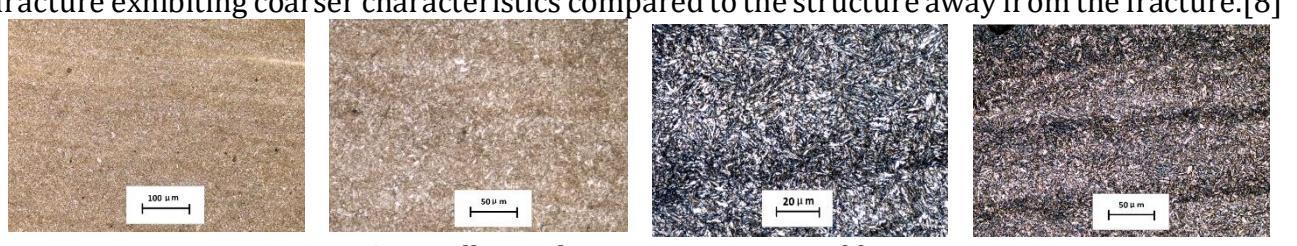
Fig. 9 Metallographic microstructure of fracture

The internal structure of the metal undergoes alterations in response to changes in external conditions or intrinsic factors. Through an analysis of the metallographic structure, one can assess whether there have been modifications in the organization and properties of the failed component. Image 9 illustrates the metallographic structures at locations distant from and proximate to the fracture site. The metallographic examination reveals that both the matrix structures near the fracture and those far from it consist of tempered martensite, with no apparent reticular formations observed at the grain boundaries, aligning with the prescribed standards for the metallurgical structure of this 40CrMoA material. It is evident from the image that the microstructures of both locations are relatively coarse, with the structure near the fracture exhibiting coarser characteristics compared to the structure away from the fracture.[8]

The metallographic microstructure images of the bolt fracture surface reveal that the metallographic microstructure of the bolt matrix is tempered martensite. This suggests that the bolt has undergone quenching and high-temperature tempering treatments, resulting in excellent comprehensive mechanical properties. Notably, the presence of some ferrite in the image is observed. Ferrite, known for its low hardness and good plasticity, effectively strengthens the steel without compromising its plasticity and toughness, thereby optimizing the steel's performance.
