Fault Diagnosis and Precaution on Cracking of Suspension Clamp on Transmission Line

Abstract. In order to fault diagnosis of suspension clamp, combined with the common faults and causes of suspension clamp, By macroscopic examination, metallurgical testing, hardness testing analyzes the failure of a certain overhead lines XGU-3 type U-shaped screw-type suspension clamp, the reason fo clamp fracture is in the long run process, for the effects of wind, the impact of span, the impact alignments, the terrain, the impact of surface features cause ear hanging plate friction between the shaft and trunnion gradual wear and tear, ultimately the critical strength insufficient lead to fracture. Finally, propose the suggestions to prevent the fault of suspension clamp.

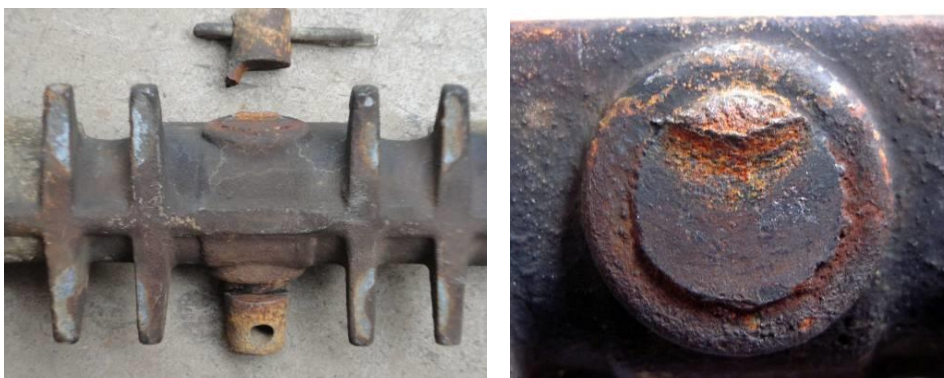
42 on the left ear clip a shaft not wear off, wear depth 7mm (see Figure 2); another trunnion wear off, the fracture in two distinct parts: one severe corrosion for long-term wear and tear caused by outdated uniform fracture, wear depth 11mm, this part represents approximately 80% of the fracture area, another part of the final instantaneous fracture zone in the region remaining 5.0mm, about 20% of the fracture area (see Figure 3). # 42 on the right sides of the clip are significant wear of the trunnion, and the depth of wear was 4mm 6mm (Figure 4, Figure 5, Figure 6).

Fig 2 Fracture # 42 suspension clamp Fig 3 # 42 bar suspension clamp fracture

comprehensive inspection, especially in the conduct audits under certain adverse operating conditions, severe wear should be replaced immediately.

Improve the structure of the process suspension clamp: Improved suspension clamp manufacturing materials, such as the application of high hardness materials, processing, or wear ear axis margin increased wear trunnion suspension clamp, increase siding with rotary clamp the friction area, the use of bag-type suspension clamp for suspension clamp plate and clamp body parts of slotting treatment [11]. Damping measures to strengthen the ground, effectively reduce wind-induced vibration on the ground suspension clamp and ground damage.

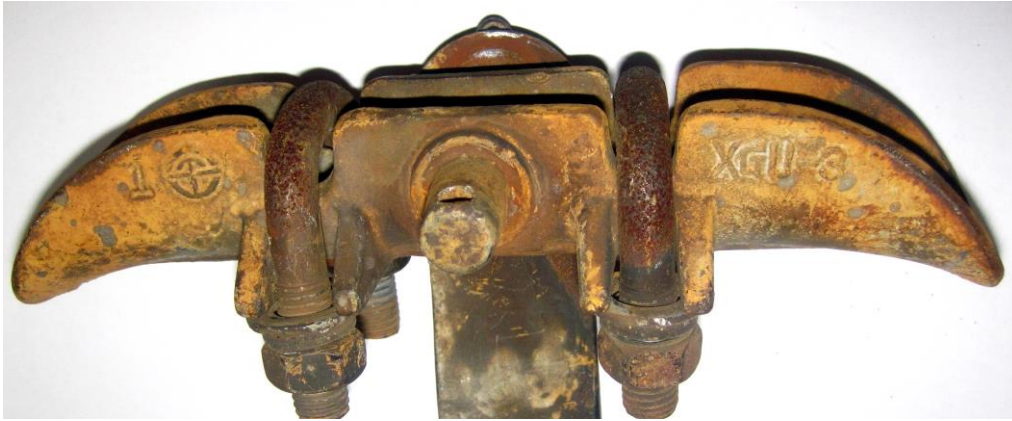
Fig 4 # 42 on the right side suspension clamp

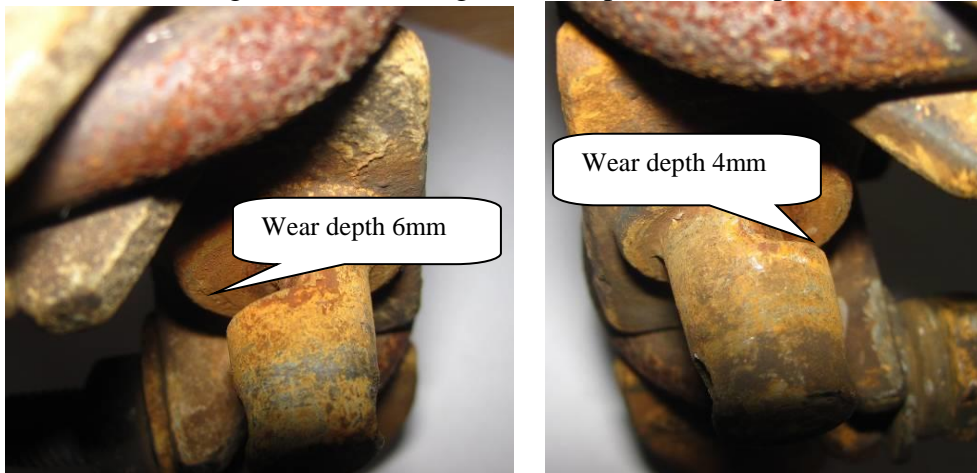
Fig 5 # 42 suspension clamp A trunnion Fig 6 # 42 suspension clamp B trunnion
