The investigation and study of the damages of simple supported beam bridge in the Wenchuan earthquake

Abstract. Wenchuan earthquake causes a lot of bridges damaged, and brings a lot of difficulties to the rescue work. In all of the damaged bridges, the simply supported beam bridge accounts for a large part. At the same time, all these years, earthquake disaster frequently occurs. Through investigating the damage of the simply supported beam bridge in the Wenchuan earthquake, it can get its aseismic measures for the design and construction.

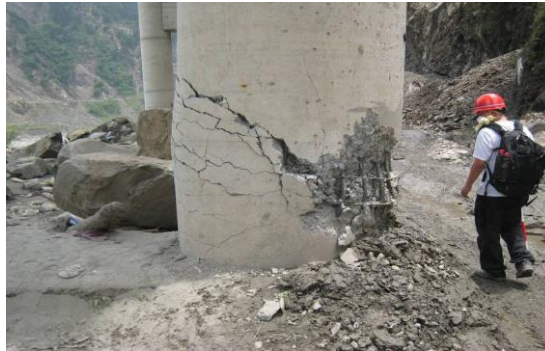
Fig 1. The damage of lowering of girder

Increase the width of the pier cap beam to increase the support length of beam, which increases the support length of beam, and it can effectively avoid the upper structure in the earthquake ended beam. At the same time, falling device can avoid falling bridge design and construction of waterproofing good, such as adding restrainer, additional beam shear blocks on both sides and strengthening the anti-earthquake block.

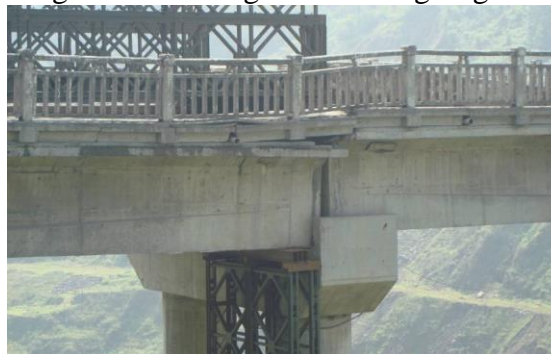
Fig 2. The damage of bridge pier

Ductility design of bridge piers should be fully considered, and it should use diameter greater than 12 mm as the stirrups with HRB400 reinforced bar. The stirrup is encrypted, so as to ensure the sufficient rate of stirrup. And it ensures that there is sufficient constraint on the core concrete. In addition to the stirrups, there also must be enough lacing wires between the main reinforcements in order to strengthen the constraint effect on concrete.

The joint of reinforcing steel bar is relatively weak for the bridge pier. And this part is easy to break when the earthquake occurs. The lap joint of main reinforcements should be of sufficient length to avoid emerging the weak form.

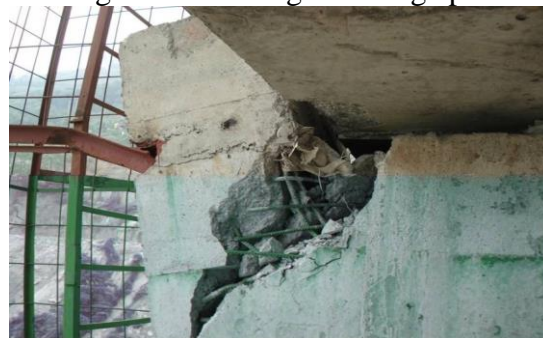
Fig 3. The damage of bridge abutment

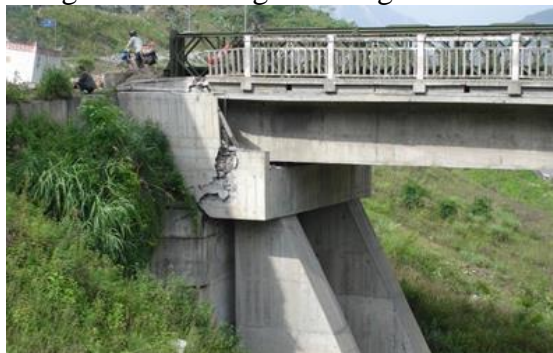
Fig 4. The damage of rubber plinth

Bridge bearing bears the superstructure and piers, and column plays an important role in connecting and transferring the stress and deformation, and it is the weak link of the bridge seismic damage examples. In the past, bearing damage is relatively common, and the collision of adjacent girders and beams, longitudinal and transverse displacement, most are based on the bearing failure the preamble. In general, the cause of bearing damage which supports in the earthquake effect of stress is complex, and the design does not fully consider the seismic requirements. The retaining structure measures are inadequate, and the support material defects and the form are also the cause of bearing failure. For the earthquake zone bridge, the bearing quality will effectively reduce the lower ductility demand, and improve the safety of the bridge.
