## Performance Issues of Pavement With Cementitious Stabilized Layers (CSL)

### Abstract

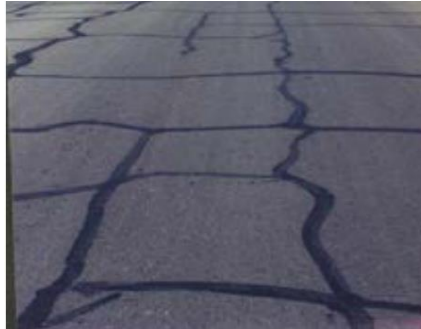
Fig.1 Block Cracking in HMA with Stabilized Base (Scullion 2002)

Block cracking often is reported in the HMA surface when the pavement has a stabilized base. Block cracking is caused by shrinkage of the underlying stabilized base and often occurs when the HMA layer is thin, as for local roads (Fig. 1). Highways in many parts of the world that use stiff bases and thin HMA layers also have encountered this problem (Yue 2004, Zube 1969). The shrinkage, caused by a loss of moisture and temperature variation, typically initiates shortly after construction and continues thereafter. According to Zube (1969), high unconfined compressive strength (UCS) causes block cracking which is likely due to the high shrinkage of CSL with high cement content and high strength. In short, block cracking can be attributed to the shrinkage of CSL.

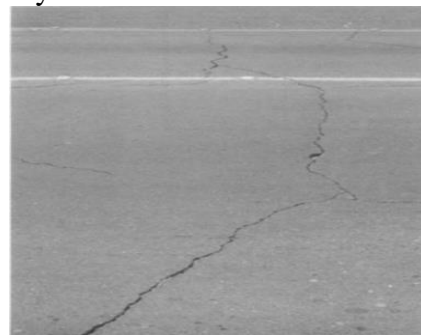
Fig.2 Transverse Cracking due to Shrinkage Cracking of CSL (Freeman and Little2002)

Transverse cracking in the surface layer that results from shrinkage of the stabilized base, as shown in Fig.2, starts from the bottom of the surface layer and propagates through the surface layer. The cracking is due to the bond between the surface layer and stabilized base (George 2002). Transverse cracking is also a concern for pavements with a stabilized subbase and granular base, but at a much later stage (Ramsey 1959). The shrinkage cracking of the subbase causes stress concentrations at the locations of the cracks and eventually affects the stress distribution in the surface layer.
